ETL 1110-2-286

25 July 1984

Engineering and Design  
USE OF GEOTEXTILES\* UNDER RIPRAP

1. Purpose. This ETL provides information on experiences with geotextiles under riprap on the Tennessee-Tombigbee Waterway.
2. Applicability. This ETL applies to all HQUSACE/OCE elements and field operating activities having civil works responsibilities.

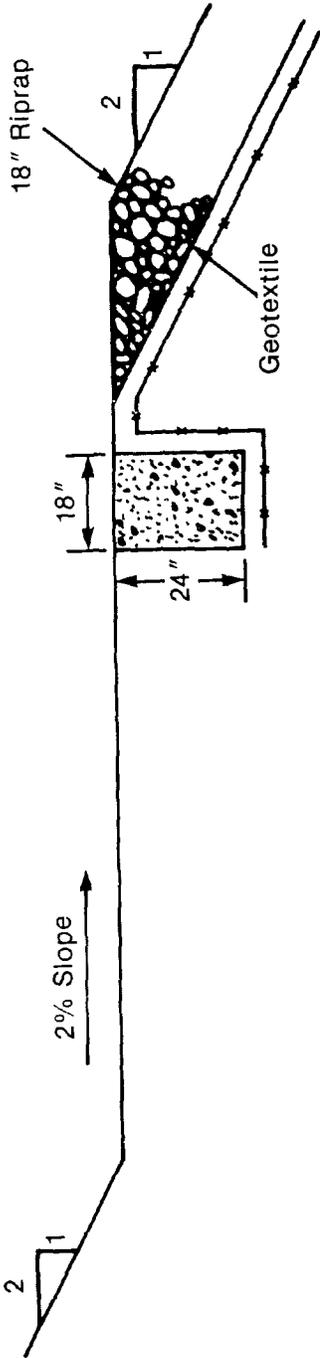
FIGURE 1. Entrenched Geotextile at Top of Slope.

c. Placing the upper end of the geotextile in a trench at the top of slope was found to be a good practice to help control surface runoff. However, if the trench was backfilled before the bedding or riprap was placed, the geotextile was stretched tight and became more susceptible to puncturing and tearing.

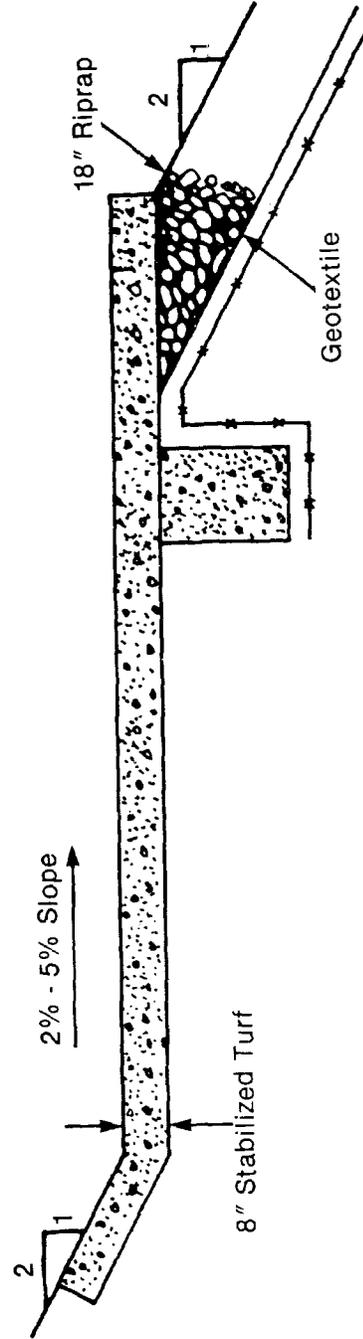
Figure 2. Stabilized Berm of Variable Slope Extending Over Riprap Combined with Entrenched Geotextile.

11. Surface Water. Failure to properly handle surface water resulted in many failures. The concept of sheet runoff was used in design but this proved to be inapplicable since the runoff tended to create channels in the highly erodible soils and undermine the geotextile. The geotextile was either clogged, of too low a permeability, or not in contact with the soil, causing the water to percolate down the slope under the geotextile instead of up through the textile and then down the slope on top of the textile. Any punctures or tears in the textile allowed the trapped water to exit and carry materials with it. Slumps or depressions in the riprap resulted, and in cases of heavy or prolonged rainfall, a complete washout and failure occurred. Burying the geotextile 2-3 feet deep in a trench at the top of slope after riprap placement helped greatly to control erosion, but it was not a complete solution (Figure 1). Modifying berm slopes and stabilizing berms with small rock were also tried and met with varied success (Figures 2 & 3). Collector systems for the runoff proved to be the best and most reliable overall solution but were expensive. Various combinations of ditches, paved channels, and pipes were used successfully. Figure 4 shows a typical collector system. See Inclosure 1 for Figures 1 thru 5.

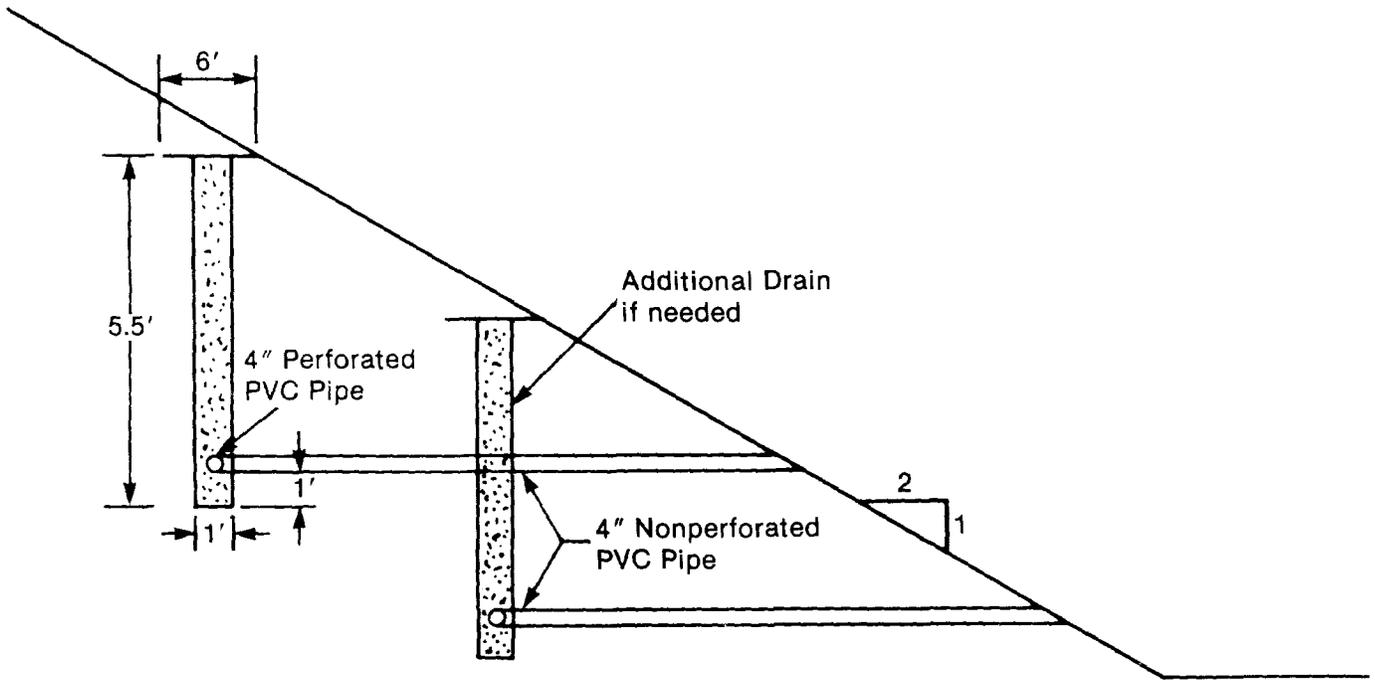
**FIGURE 5. Typical Lateral Drains for Groundwater Seepage Control.**

12. Groundwater. Groundwater seeping out of cut slopes also presented problems. Coupled with the highly erodible and horizontally laminated soils, the groundwater seepage eroded the slopes badly and created soft unstable areas. Extensive slope preparation was required to correct the erosion problem. Interceptor trench drains parallel to the waterway center-line were required to stabilize the slopes before the geotextile and riprap could be placed. These drains were installed as determined in the field, with as many as six lines of drains needed on a single slope. Figure 5 is a typical section of these drains.
